Caltrans Division of Research,
Innovation and System Information

Research Results

Project Title:
Load Testing Bay Bridge
Expansion Joints

Testing whether a new type of thermal and seismic expansion joint can withstand heavy traffic on the Bay Bridge

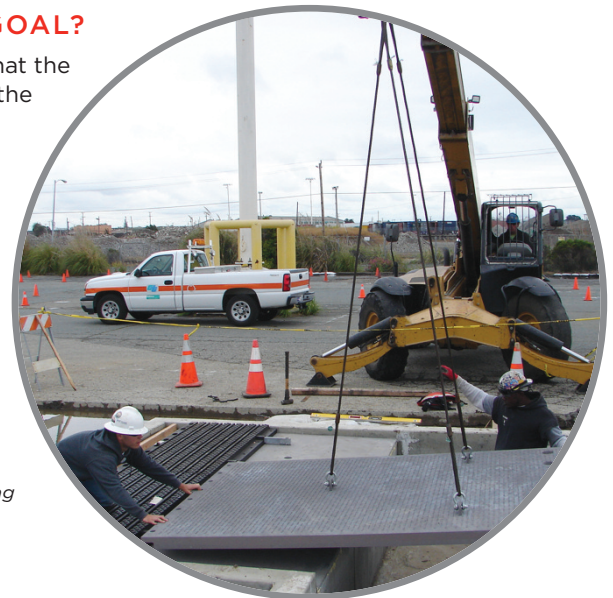
*Workers assembling
the mock-up joint for testing*

A test structure incorporating a full-scale joint was constructed close to the bridge. A total of 1.36 million load repetitions, equating to about 46 million standard axle loads on a highway pavement, were applied in seven phases during the three-month test. During this test, no seismic or structural testing was undertaken.

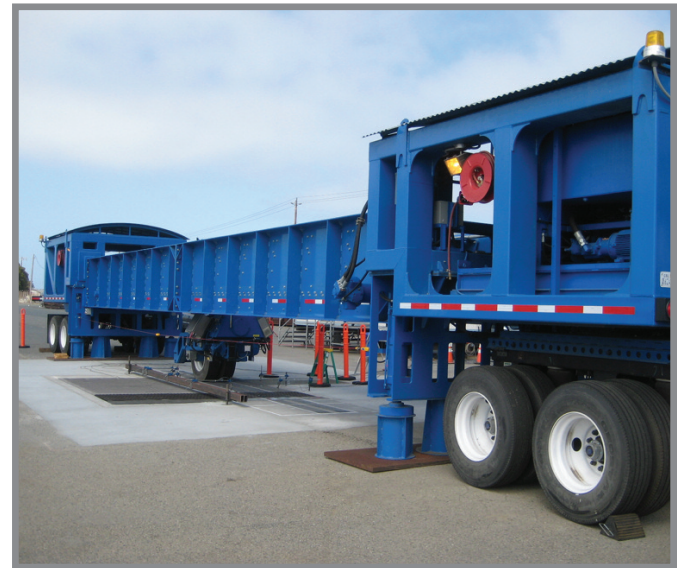
HVS testing on the deck joint

Caltrans, in partnership with the University of California Pavement Research Center, used an HVS to gain a quick indication of how the joints would perform under truck traffic.

No structural damage was recorded by any of the linear variable differential transducers (LVDTs) or strain gauges that were installed on the steel plates, steel frames, bolts, and washers. There was also no visible damage on any of these components. In the last phase of the test, excessive overloading with a 150 kN half-axle load on an aircraft tire, which is approximately four times the standard axle load, caused some damage to the Trelleborg unit in the joint. The damage included abrasion, tearing, shoving, and permanent deformation of the rubber inserts, as well as deformation and shearing of one of the steel supports directly under the wheel load.
